SECOND SITE INSPECTION REPORT (SI2)

EISENBERG FILL SITE ALIAS: LEO EISENBERG'S PROPERTY

CLAY COUNTY, MISSOURI

August 7, 1995

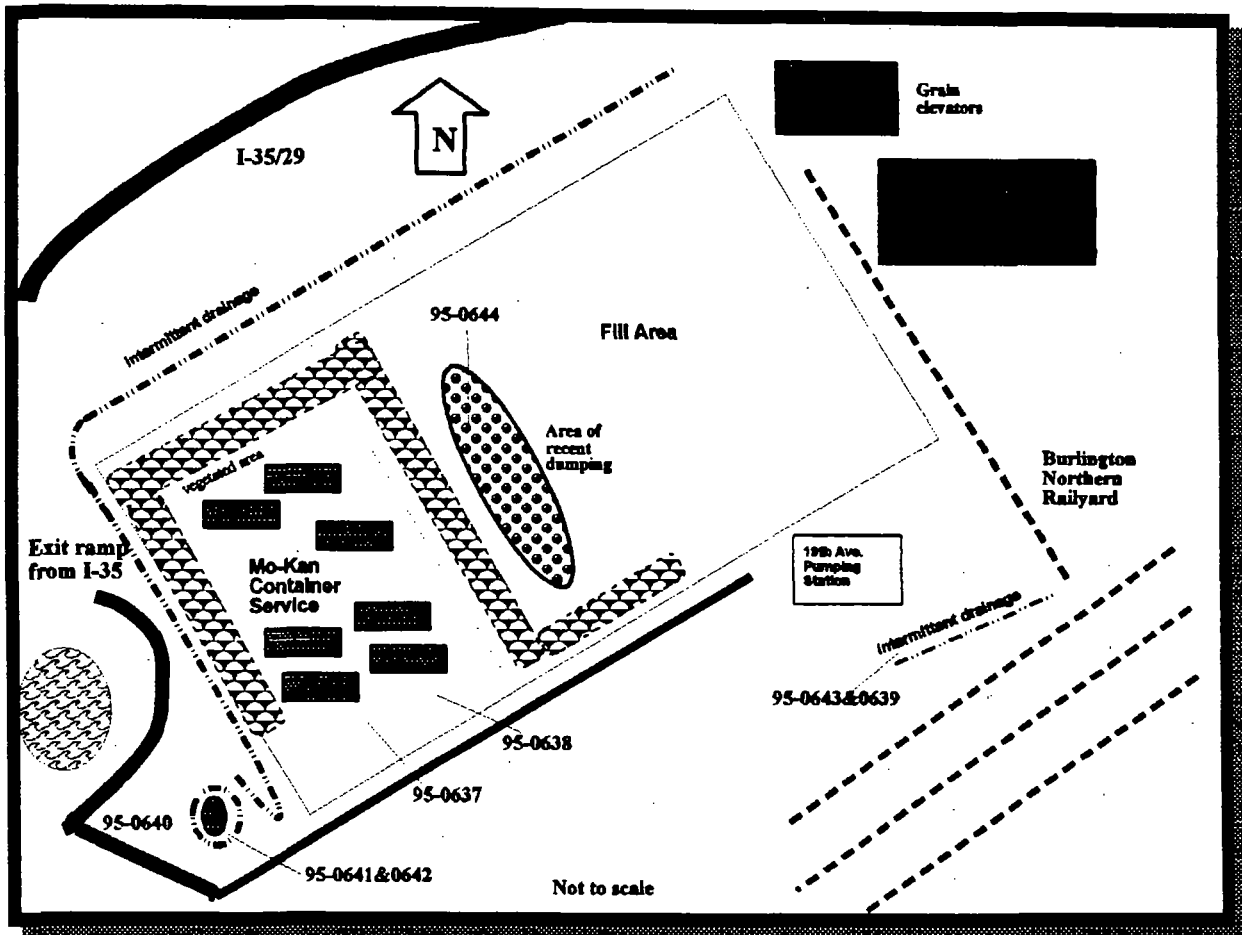
Figure 1 - Eisenberg Fill Site Map With SI2 Sampling Locations

An area of recent dumping was observed during the MDNR on-site sampling on April 27, 1995 (Reference 13; location is marked in Figure 1). The material appeared to be a type of sludge (photo #46-17A). A sample of this material was collected from a pile similar to the one depicted in #46-17A, for analysis. Piles of this grayish, sludge-like material were observed to be scattered across the northern 20 acres of the Eisenberg property. (Reference 44).

SI2 sampling rationale is presented as Appendix A. SI2 sampling locations are shown in Figure 1.
